CASE STUDY - TALISMAN SQUARE, GUELPH, ON

DRYVIT PLAYS KEY ROLE IN OVERCLADDING AN OCCUPIED APARTMENT BUILDING

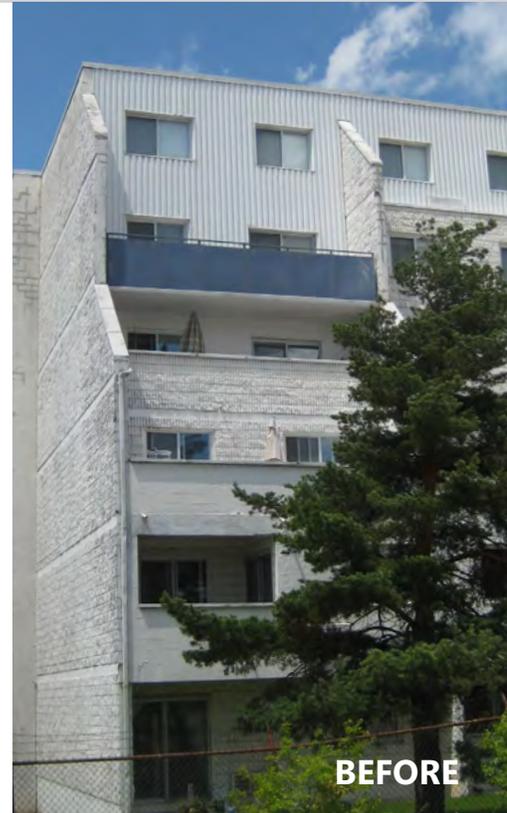
BEFORE

The exterior concrete block and steel elements of the building were deteriorating. Decades of moisture penetration had begun to undermine the load bearing, split-rib masonry in localized areas and the steel lintels above windows and doors were corroding. “If we stood by and did nothing the buildings would crumble,” says Mike Balnar, President of the property’s management company, Balnar Management Ltd.

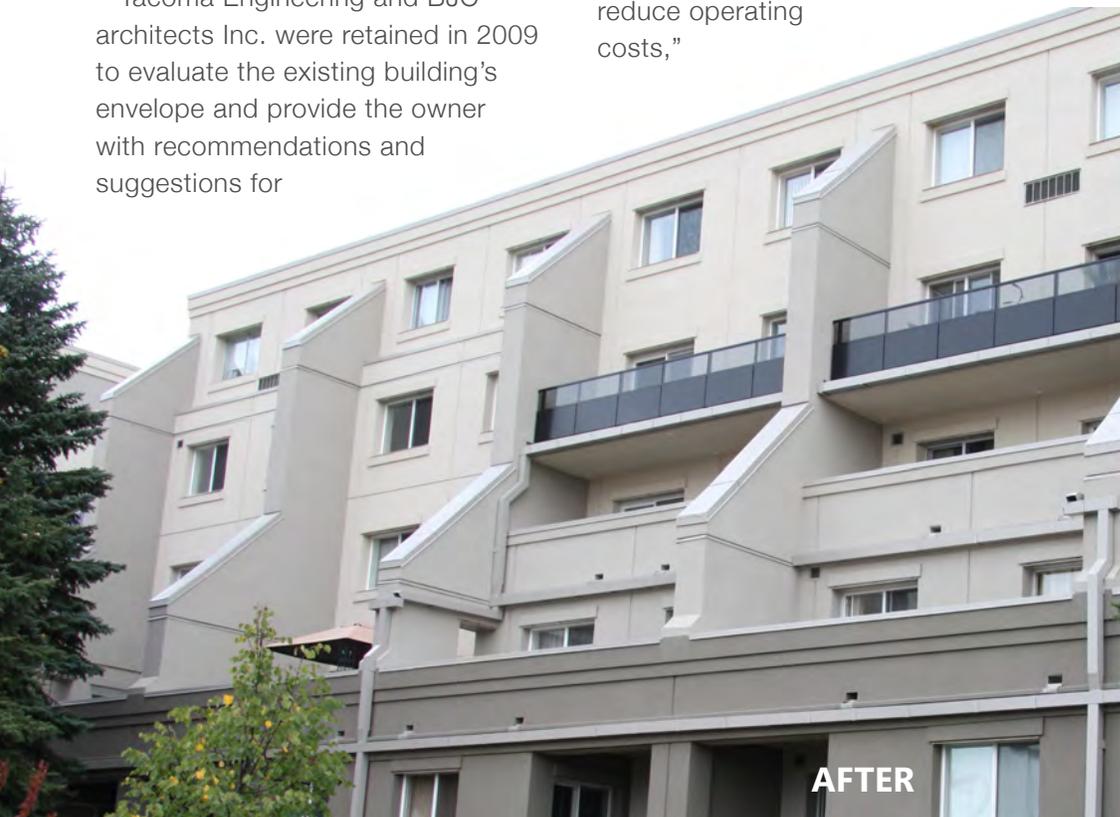
AFTER

The Outsulation® Plus EIFS (with drainage capability) assembly was applied to roughly 100,000 square feet of the building's exterior. Following the installation of GlassRoc sheathing by Balnar's forces, Backstop™ NT water resistive barrier and the EIFS assembly was installed by CMT Plastering Inc., an established Kitchener-based firm. Installation of the Outsulation Plus assembly spanned the 2012/13 seasons.
