# Outsulation® Case Study

**A green demonstration project in Las Vegas shows the nuts and bolts of a green retro fit.**

**The team preserved the integrity of the existing structure while bringing it to net-zero energy.**

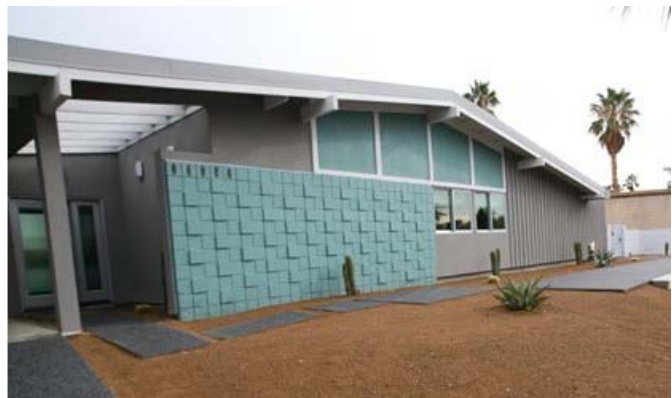
application process culminating with an acrylic-based finish coat with the appearance of traditional stucco. There are numerous other textures and colors available with a Dryvit system, but we wanted the ReVision House to mimic the original removed stucco. Applied over 2" of expanded polystyrene insulation (EPS), the Dryvit system provides an additional

R-8 to the wall assembly (for a total R-value of 21.6). Since the Dryvit system is applied over all of the opaque vertical wall surfaces, a continuous thermal break between the exterior weather and the cavity-insulated wall assembly is achieved. The Dryvit product is installed over structural sheathing (Las Vegas is in a high-risk seismic zone). A water resistive barrier and drainage plane (Tyvek® StuccoWrap®) is then installed, followed by the two-inch EPS insulation. A reinforced base coat is applied over the EPS, and finally the finish is applied. The result is a thermally efficient exterior wall with the performance level needed to meet our ZEH goal, and true stucco appearance compatible with our iconic home.

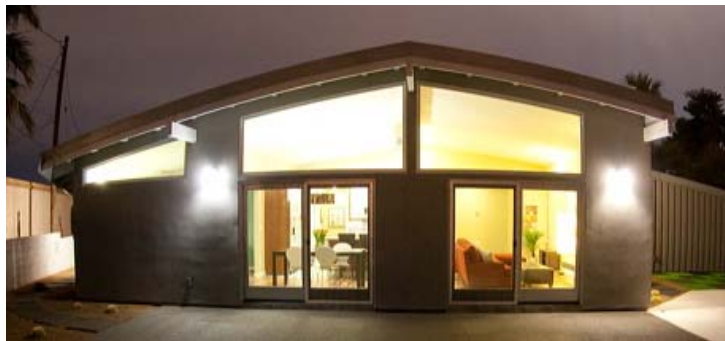
This includes the front (west facing) clerestory glass in the master bedroom. Since the trapezoidal clerestory glass is critical to the overall appearance of the home, a solution was needed which would hold true to the home's original form, but provide substantially better thermal performance

than the removed windows. The solution? Dryvit's Reflectit™ pearlescent coating. Applied to a finely textured surface, Reflectit provides a smooth, glossy, polished surface. At the removed windows, the voids were infilled to match the adjacent walls (including insulation) and finished with contrasting panels of Reflectit in the same pattern as the removed glass.

Another Dryvit product was also used for one more task at the ReVision house. In a strategy to reduce the cooling load, windows that did not provide the needed day-lighting or views to the exterior was eliminated.
